Black Mesa Project Lowers Flooding Risk in Albuquerque's South Valley

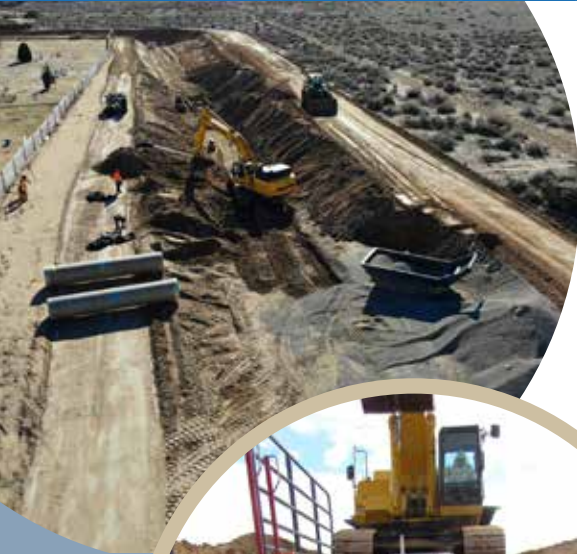
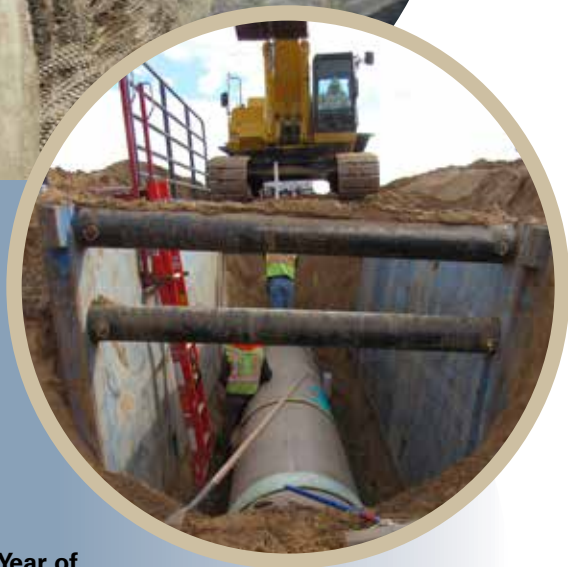
Year of construction
2019
Length
4,480 feet
Diameter
42 & 36-inch
Stiffness class
46 & 90 psi
Installation method
Direct bury
Application
Storm water
Client
AMAFCA
Installer
AUI Inc.

When selecting materials, AMAFCA chose Hobas centrifugally-cast, glass-fiber-reinforced, polymer mortar 42-inch and 36-inch pipes with tee bases and 30” flanged tops to serve as irrigation piping for agriculture.

One of the main reasons for using Hobas pipe is its pressure rating, Lovato said. “Normally we would use reinforced concrete pipe, but it doesn’t have the required 21.6 PSI pressure rating,” he explained. “Even though that may be considered a low pressure rating for Hobas, it’s high for us.”
